GOOD & MAL-PRACTICES

This bulletin aims to present poor and good practices supported by photographic material.

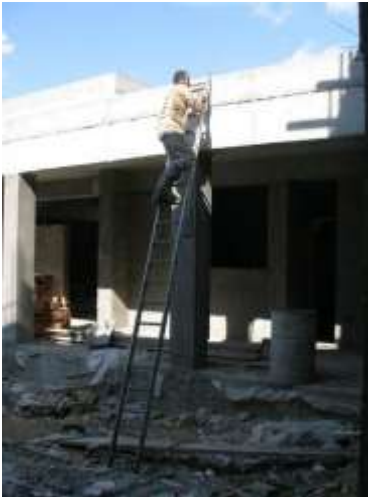
Malpractice

Hastiness, familiarization with danger are poor advisors; construction workers usually take chances disproportionate to the gain they think they acquire from their short-cuts in safety.

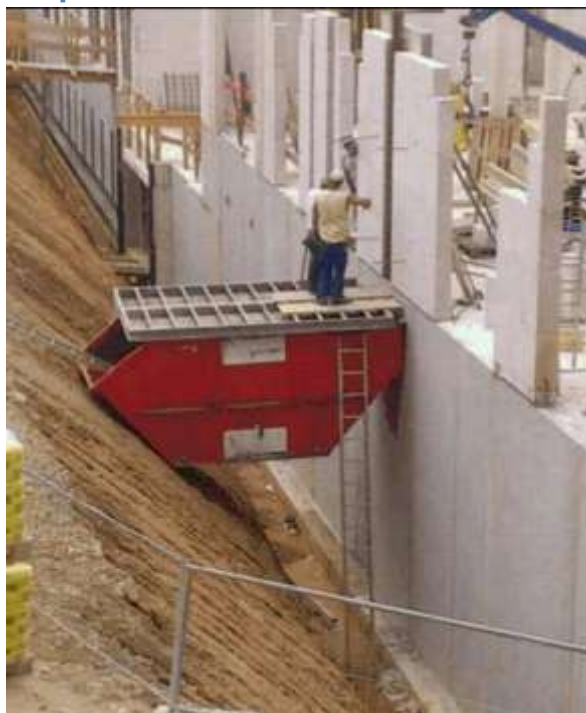
Malpractice

Poor improvisation for providing a working/ access platform in a worksite; the access ladder is also a substandard hazardous practice.

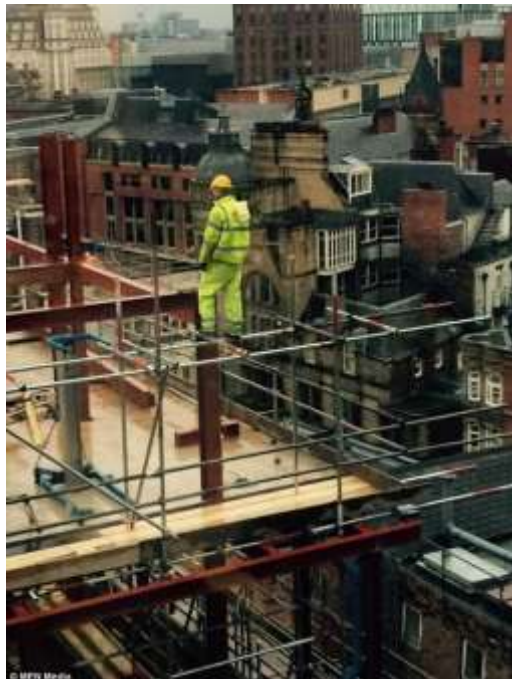
Malpractice

Picture at a Manchester worksite; this particular employee was fired.

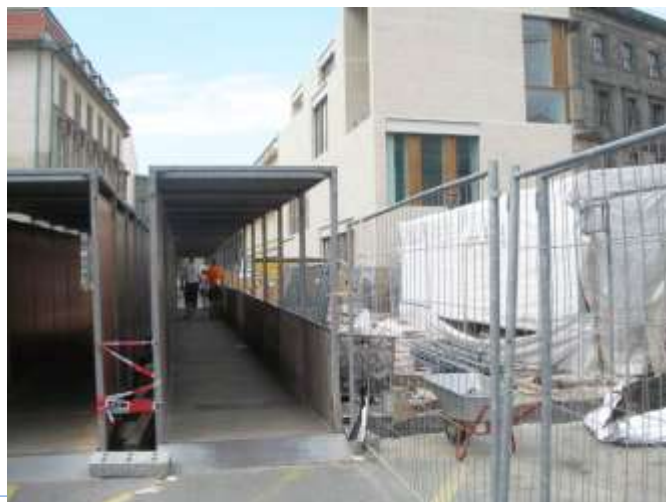
Good Practice

Walkway for pedestrian protection at a worksite in Berlin.

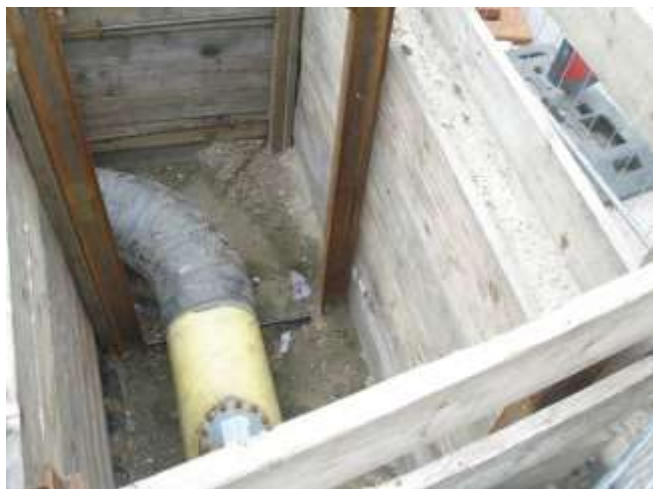
Good Practice

Excavation/ trenching rigid protection from wall collapse at a maintenance worksite in Berlin.
