Environmental impacts

This bulletin aims to present very poor environmental management practices supported by photographic material.

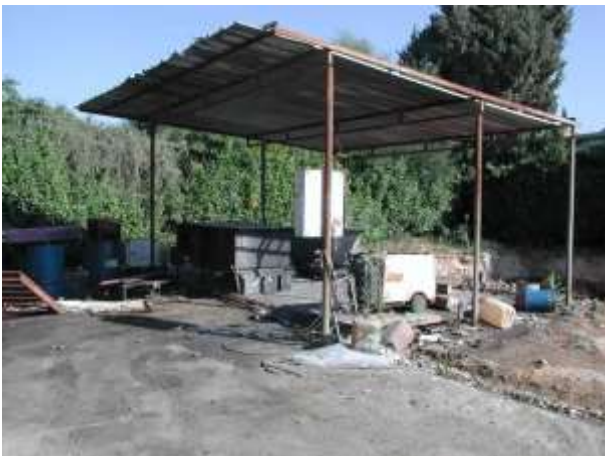
Maintenance Department “leftovers”: A substandard kiosk built to house maintenance fluids, out-of-order equipment and materials; the environmental impacts identified include soil contamination with toxic fluids (maintenance chemicals mainly acids and lubricants).

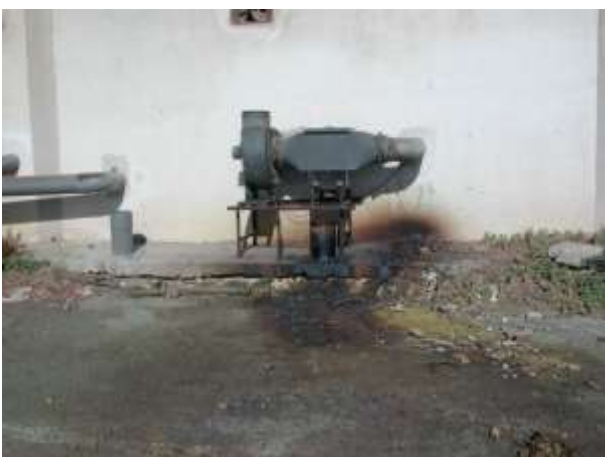
In most cases poorly maintained equipment burden the soil with oil leaks.

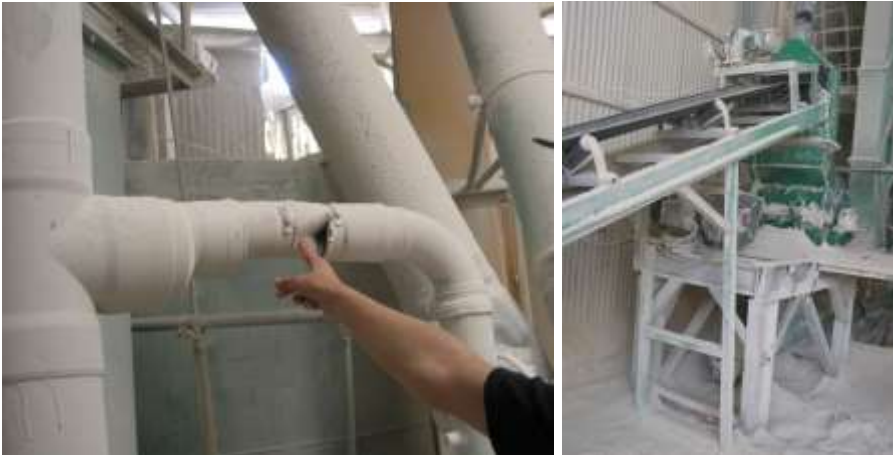
Lack of maintenance creating fugitive emissions point that creates dust pollution throughout a plasters production plant; the results are obvious throughout the facility.

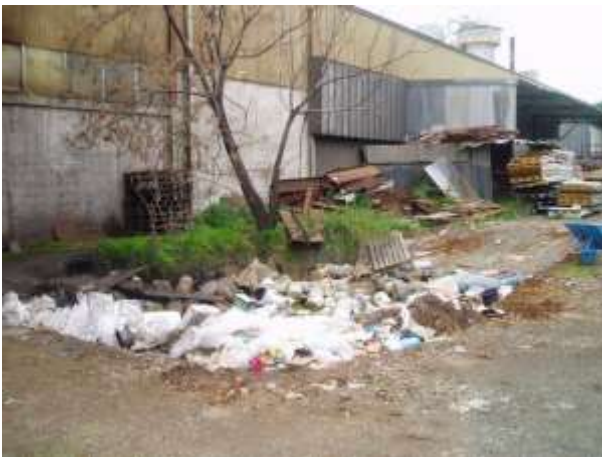
Maintenance debris after a construction work freely dumped in an open pit for subsequent burning; apart from the direct pollution to the soil, there is perspective pollution to the soil after a rainfall as well as after the uncontrolled waste burning.

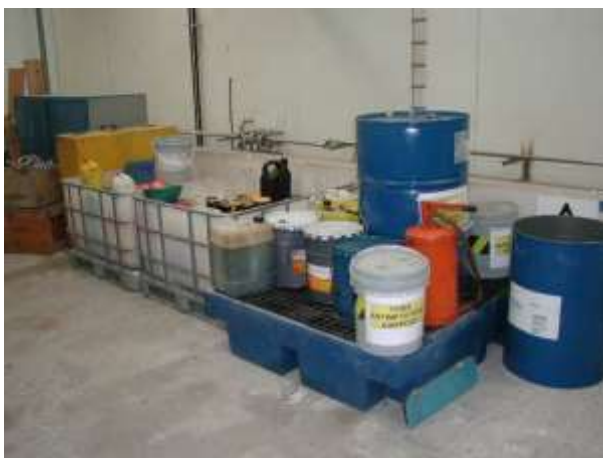
Good practice: Maintenance chemicals stored in secondary containment
